SELECTED TRANSPORTATION AND INFILTRATION ACTIVITY **SOUTHEAST ASIA**

NPIC/R-124/66 MAY 1966 SUMMARY NO 3

R-124/66

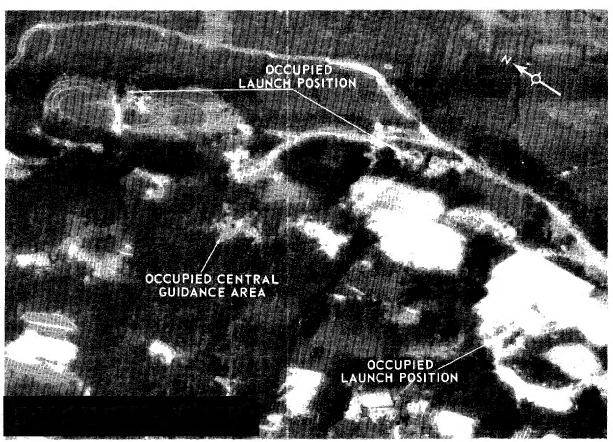
VINH SAM SITE C19-2 , NORTH VIETNAM

A new field deployed SAM Site is located 14.5 nm west- authwest of Ha Winh, 21.3 nm south of Vinh, and h3 nm north of the Mu Gia Lass Choke Point,

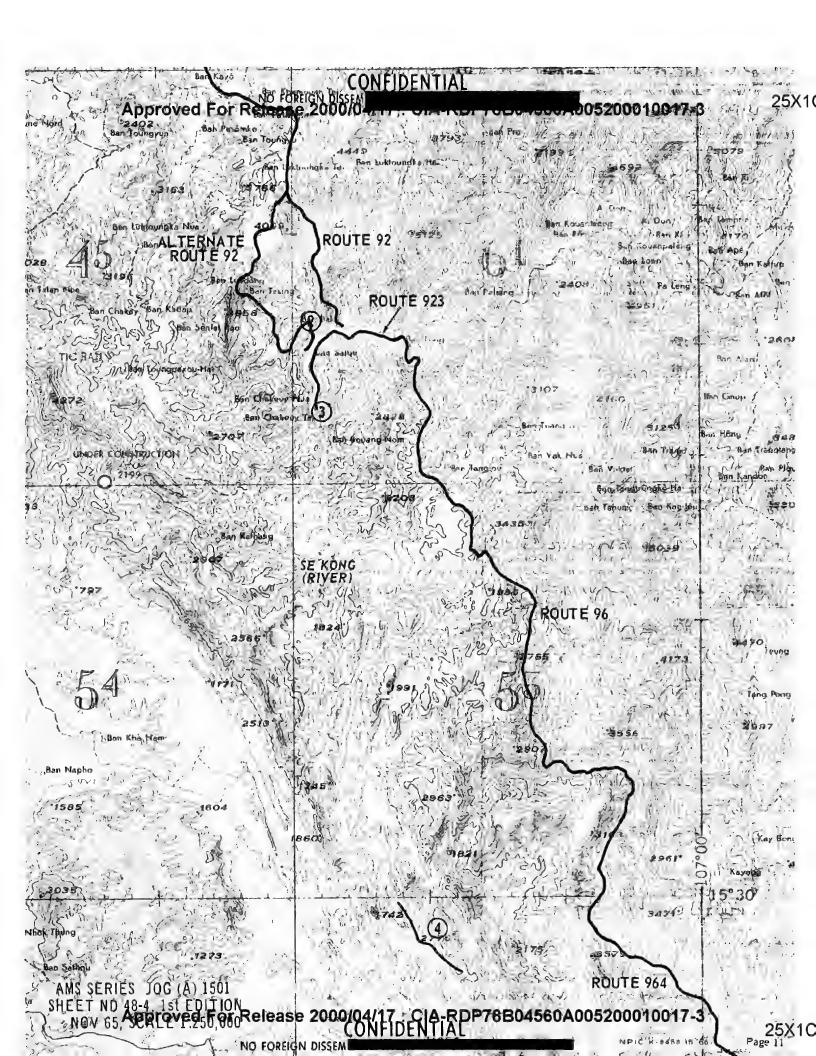
4. New Road Construction Along Route 964

New road construction, consisting of intermittent clearing operations in varying stages of completion, is observed in the Laotian Panhandle from approximately 0.7 nm southeast of the Se Kong (river), to The construction activity generally follows the alignment of Route 964, which prior to this construction consisted of an improved trail.

In ________ water-borne infiltration activity was reported on the Se Kong between 15-50N 106-46E and 15-30N 106-48E. At the same time, trails combined with this water route to form a supply line between Route 92, in the vicinity of Ban Bac, and the Chavane area. Now, the new road construction, in conjunction with the extension of Route 92,

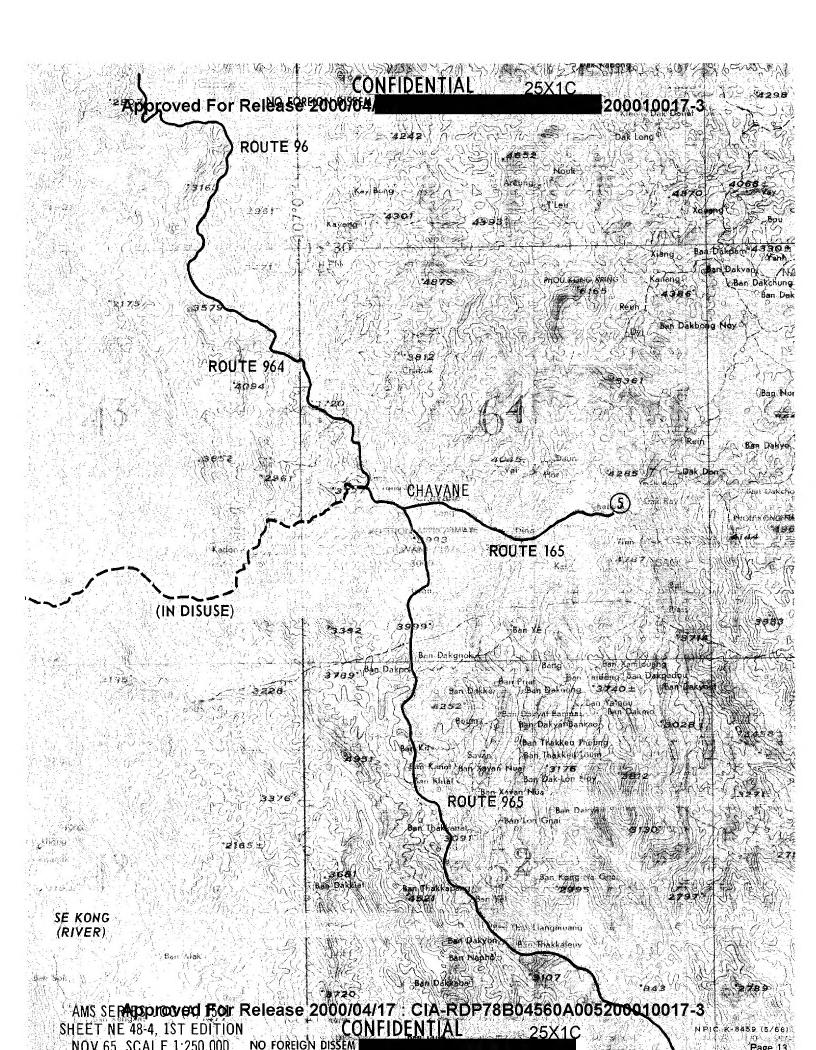
5. Truck Park and Probable Staging Area on Route 165

A truck park and probable staging area, consisting of an elaborate	
	system of interconnecting trails (some with indication of vehicular use),	25X1
	is located at the terminus of Route 165 at Wehicle tracks	23/ IL
EV1D	extend approximately 500 meters north, from the previously reported terminus	
5X1D	at into the area, by-passing a bomb crater at	25X1D
	Current usage of the facility cannot be determined due to the dense forest:	20/10
	however, the access road is apparently in limited use. A single trail	
	extends generally east from the area to become part of a complex trail	
	network which converges south of Dak Ray	
	057/47	
25X1D	25X1D	
	MPTC Cable Cite 7110 DTC 0101527 Mary 66
